BASELINE SURVEY REPORT

Project: Regeneration of Coolowyn Road and Uworra Close, Goulburn NSW

Client: Bob Philipson, Sustainable Goulburn Mulwaree

Date: 5 April 2024

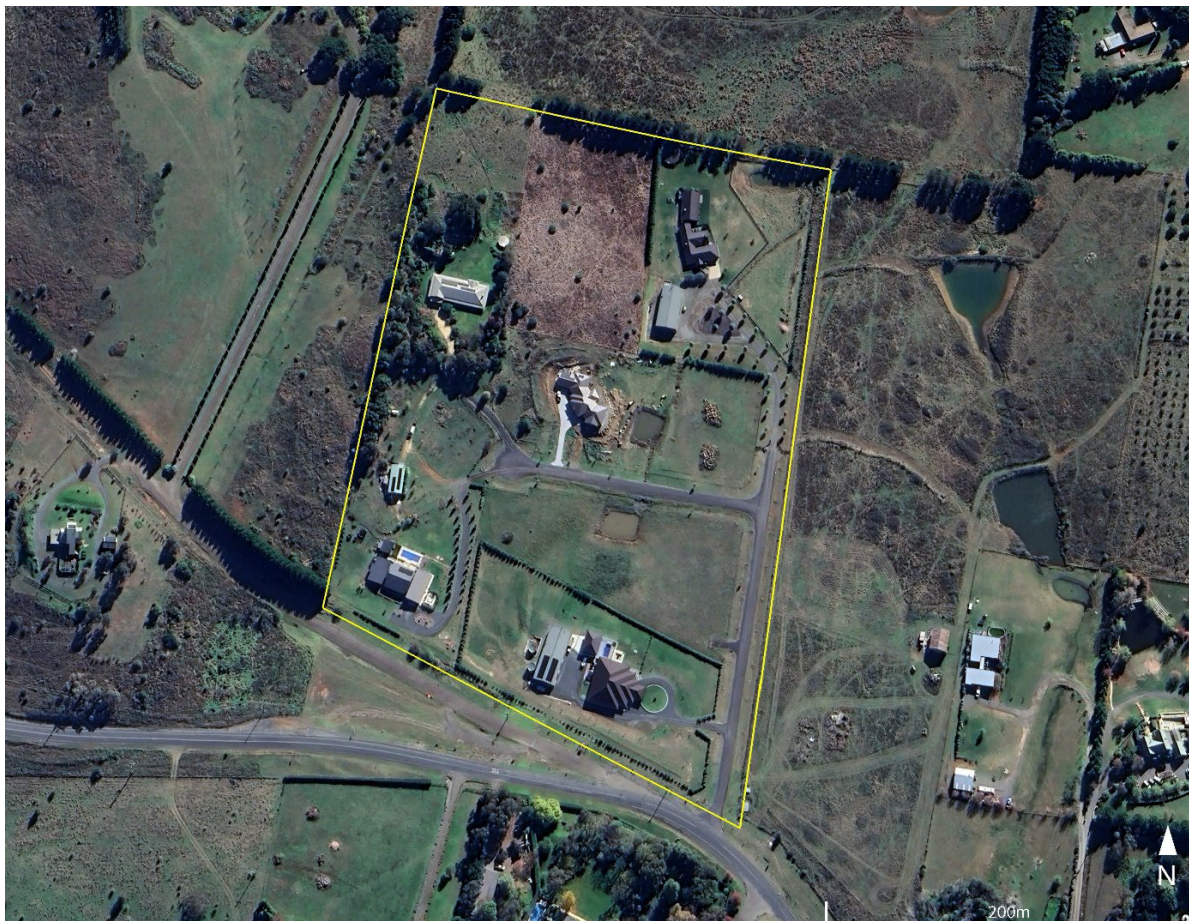
Using aerial imagery from Google Earth Pro (see below) and the tools available in that program the following canopy cover estimates were made.

Total study area = 82 381m² (20.4 acres)

Tree canopy area = 9795.24m²

Canopy cover = 12%

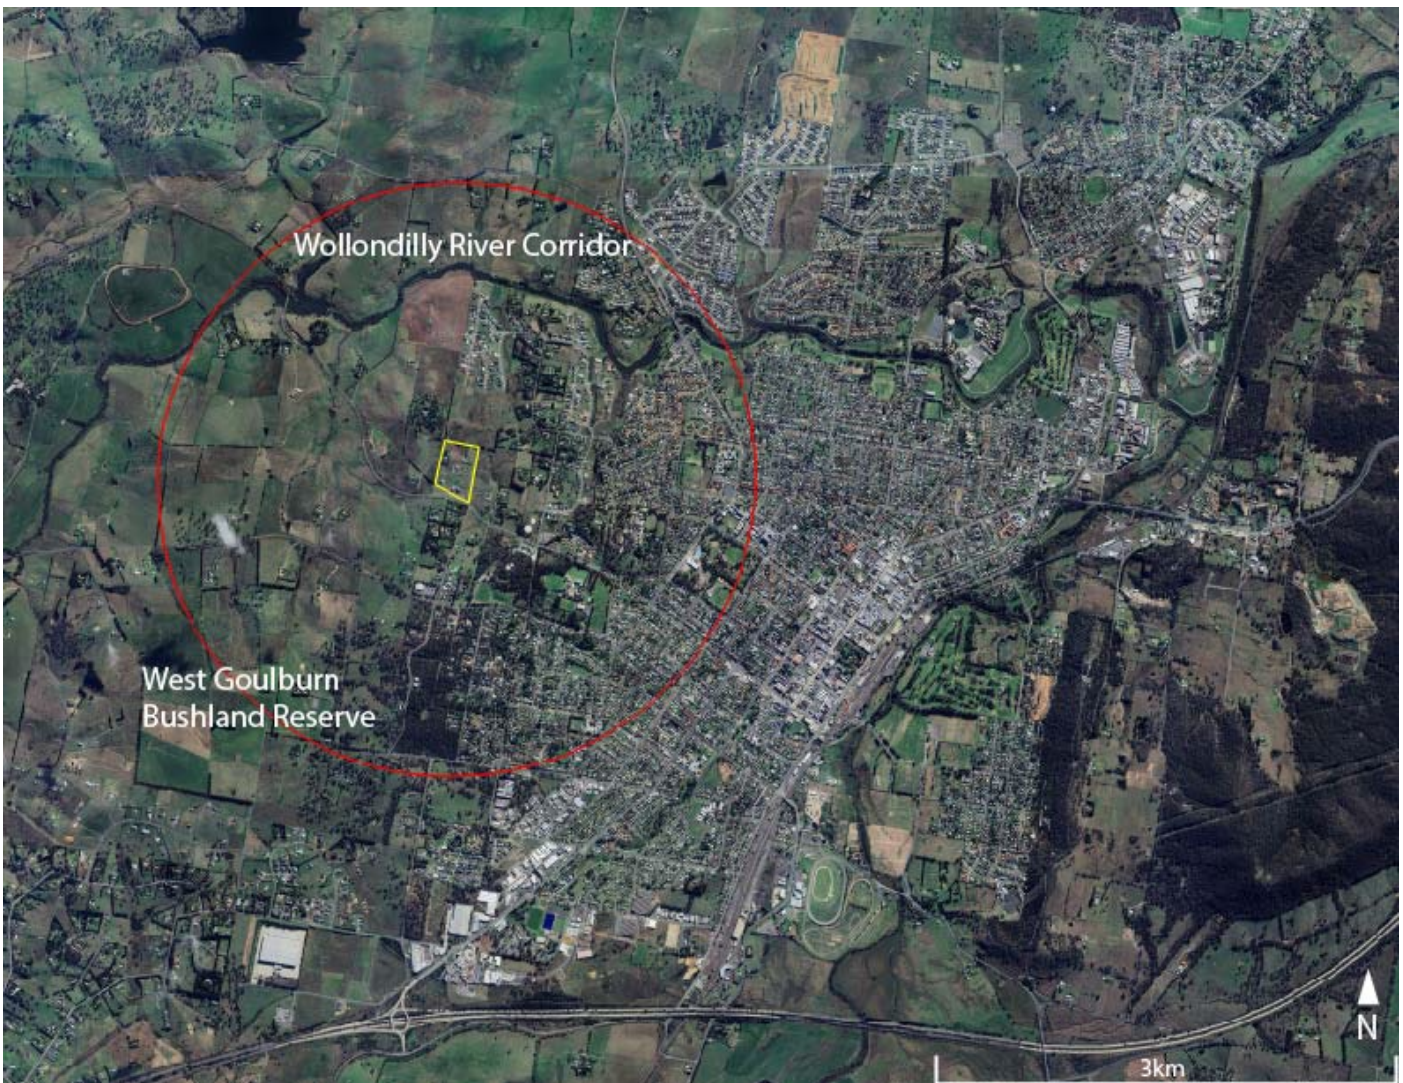
The diagram below shows the study area outlined in yellow. The red circle defines an area within a 2km radius of the study area. Two important vegetation communities within this area are identified.

The first important vegetation community within a 2km radius is the West Goulburn Bushland Reserve, a 20 ha public reserve. This area has been assessed by Lori Gould, Director Environmental Restoration Design & Planning, who found rare and threatened species in the area.

The Wollondilly River corridor is the second important vegetation community close to the study area. River corridors differ from the adjacent areas in several ways. They often have better soils, higher moisture and different plant species. For these reasons, riparian land provides the habitat features needed by many wildlife species. For some species this habitat is critical. The components of habitat that are important are food, water, shelter from predators and from harsh physical conditions and safe sites for nesting and roosting. (Australian Government, 2004)

A healthy riparian zone and strong connections to other parts of the catchment are important for wildlife. The study area is located midway between two vegetation communities. It would contribute to a corridor for wildlife movement were it to be replanted with native trees and understory plants.

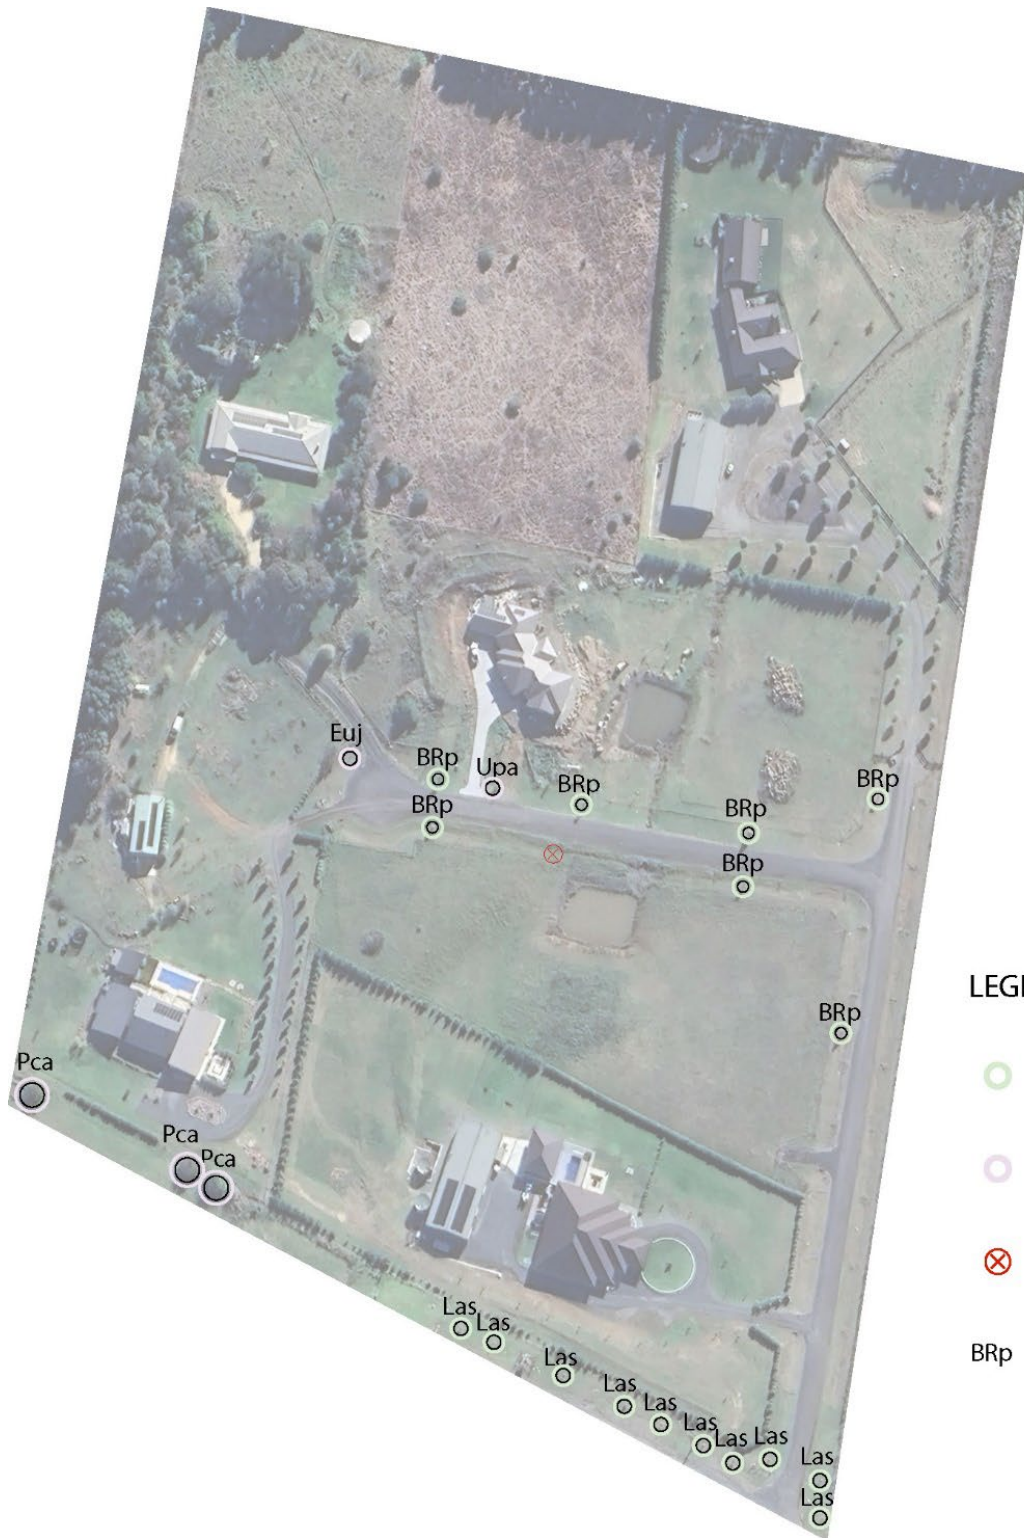
Tree assessment image

The following tree assessment includes all existing trees on public land within the study area.

Tree No / Group No	Code	Botanical name	Common name	Height (m)	Canopy diameter (m)	No Trunks	General Health	Comments	Image/s
Tree 1	Euj	Eucalyptus species - juvenile		1.8	1	1	Fair	Species difficult to identify while still a juvenile. Tree leggy with limited foliage.	 
Group 1	BRp	Brachychiton populneus	Kurrajong	2 to 3	2	1	Good	7 trees, sturdy and in good health. Note that sapling growth for this species is very slow, but these trees are established and should now be very hardy. One tree has died and should be removed.	 
Tree 2	Upa	Ulmus parvifolia	Chinese elm	3	3	1	Fair	Tree looking stressed. Perhaps suffering from too much moisture in recent wet years.	 
Group 2	Las	Lagerstroemia species	Crepe myrtle (white)	2	2	1	Good	Trees sturdy and healthy.	 
Group 3	Pca	Prunus cerasifera	Cherry plum	4	4	multi	Fair	Prunus cerasifera is regarded as an environmental weed in NSW. These trees are affected by pear and cherry slug which defoliates the leaves but will not kill the tree.

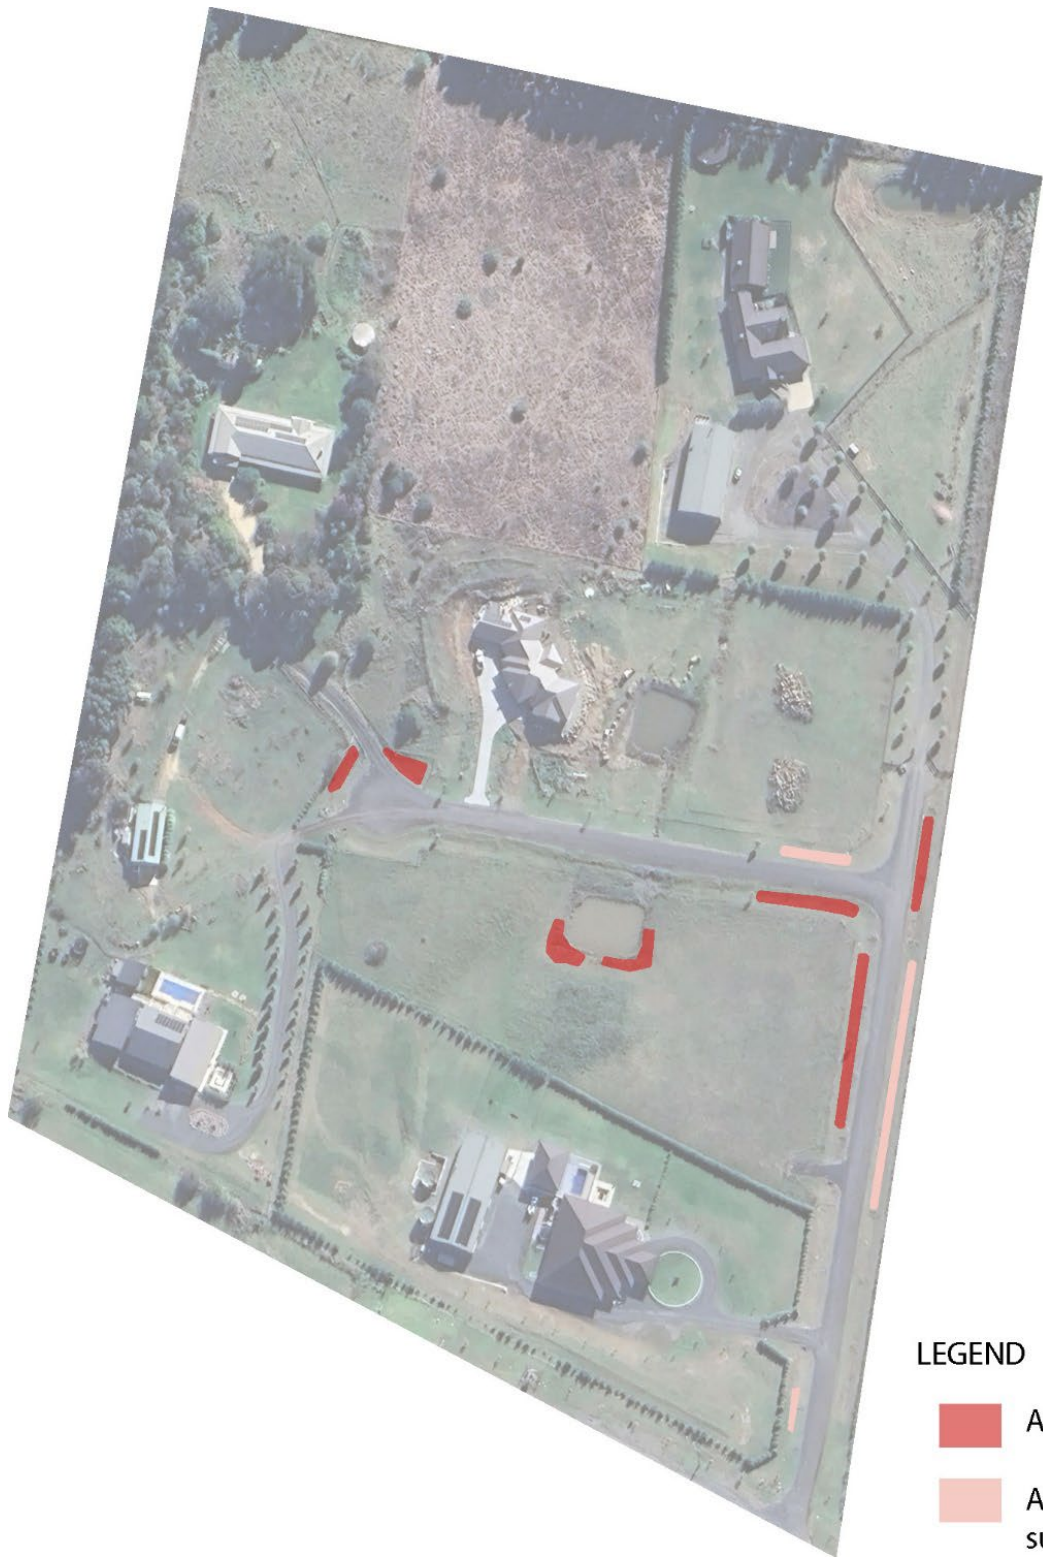
Soil erosion and soil loss results

Areas of soil erosion
-

Areas of soil loss due to surface water flow

Soil erosion occurs when unprotected soil particles are dislodged by the impact of raindrops or surface water flow. These loosened particles may then be moved by stormwater or wind. In urban areas this process is often started when a site is developed and protective vegetation is removed. The results can be damage to property by sediment deposits in streets and drains or through the silting up of downstream water bodies.

Surface cover is a major factor to control erosion because it reduces the impact of raindrops falling on bare soils and wind removing soil particles. It also reduces the speed of water flowing over the land. Erosion risk is significantly reduced when there is more than 30% soil cover. (Queensland Government, 2013)

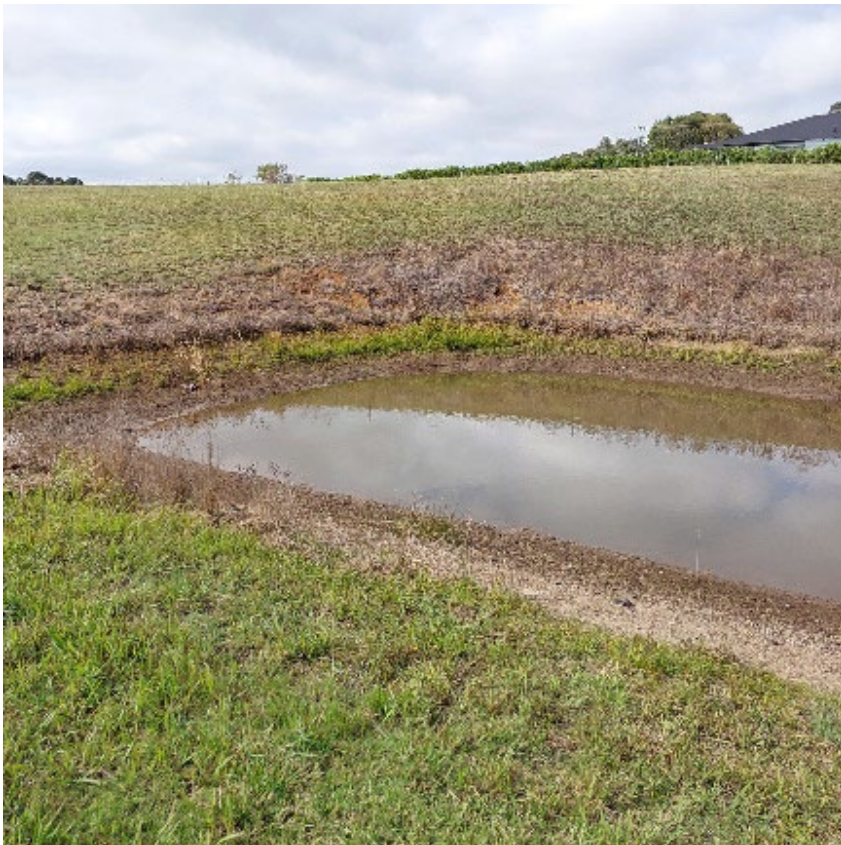
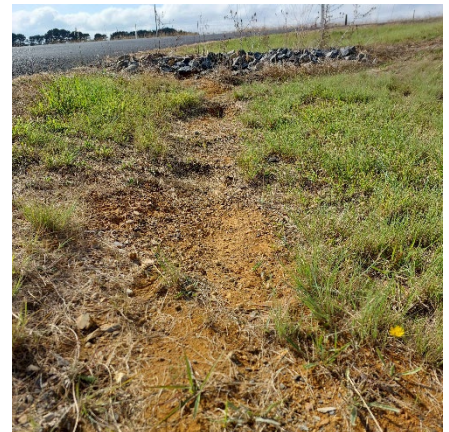
Examples of soil erosion in the study area:

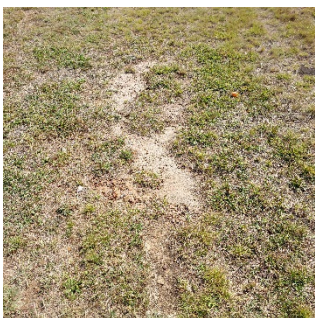
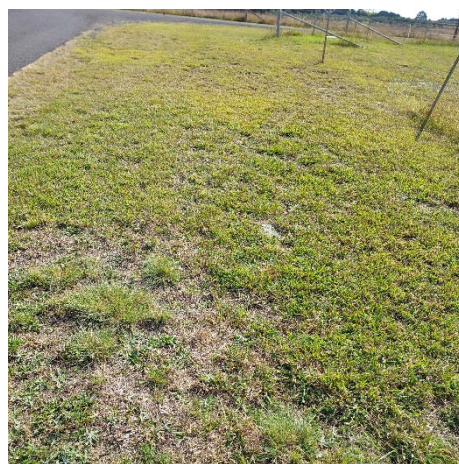
Examples of soil loss in the study area:
